Red Rock Metals, Sediment, and *E. coli* TMDLs and Water Quality Improvement Plan

October 2021

Water Quality Planning Bureau
Watershed Protection Section

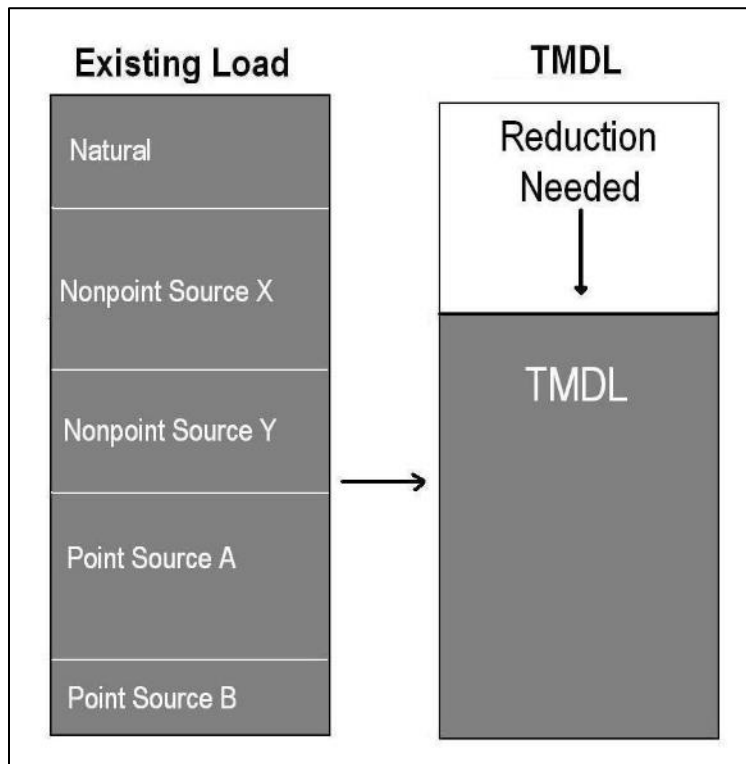
Figure 4-1 illustrates how numerous sources contribute to the existing load and how the TMDL is defined. The existing load can be compared to the allowable load to determine the amount of pollutant reduction needed.

Figure 4-1. Schematic Example of TMDL Development

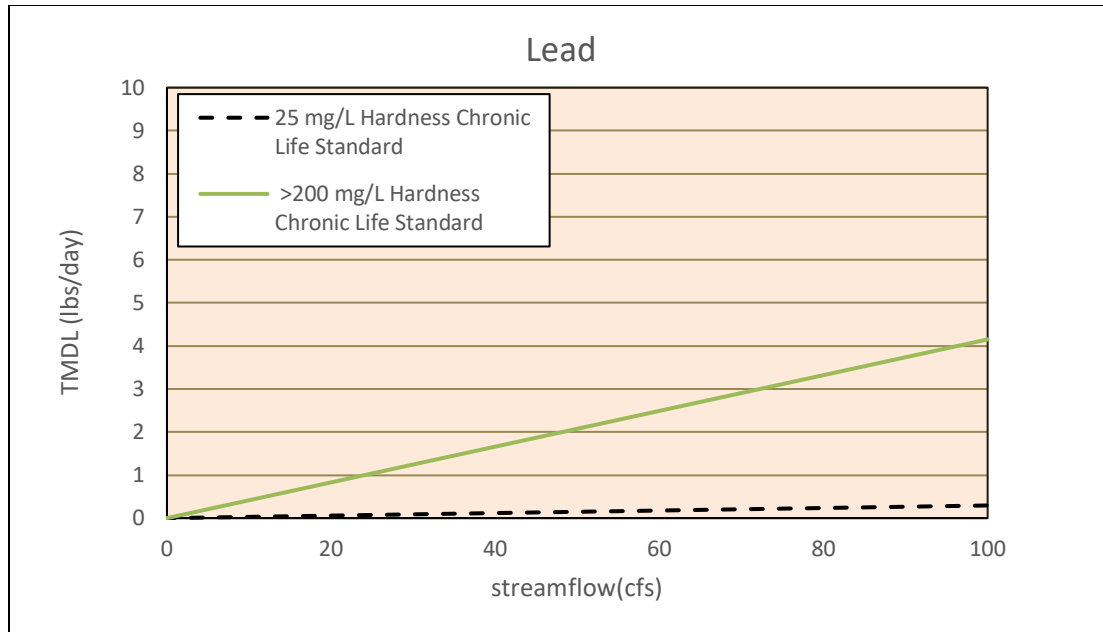
Figure 5-11 Graph illustrating the TMDL for Lead at Different Hardness and Flow Levels; Refer to Appendix C for Similar Graphs for Other Metals

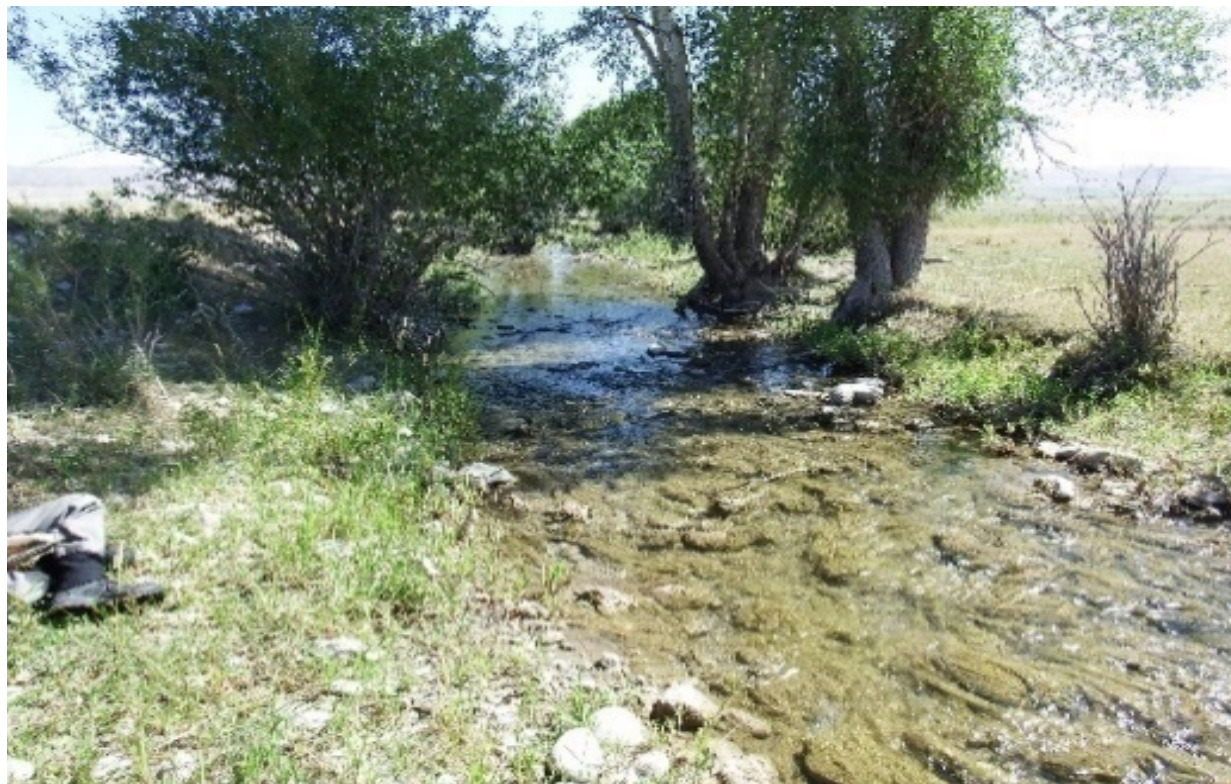
Figure 6-2. Lack of riparian vegetation, sediment, and filamentous algae at BGS10-02a.

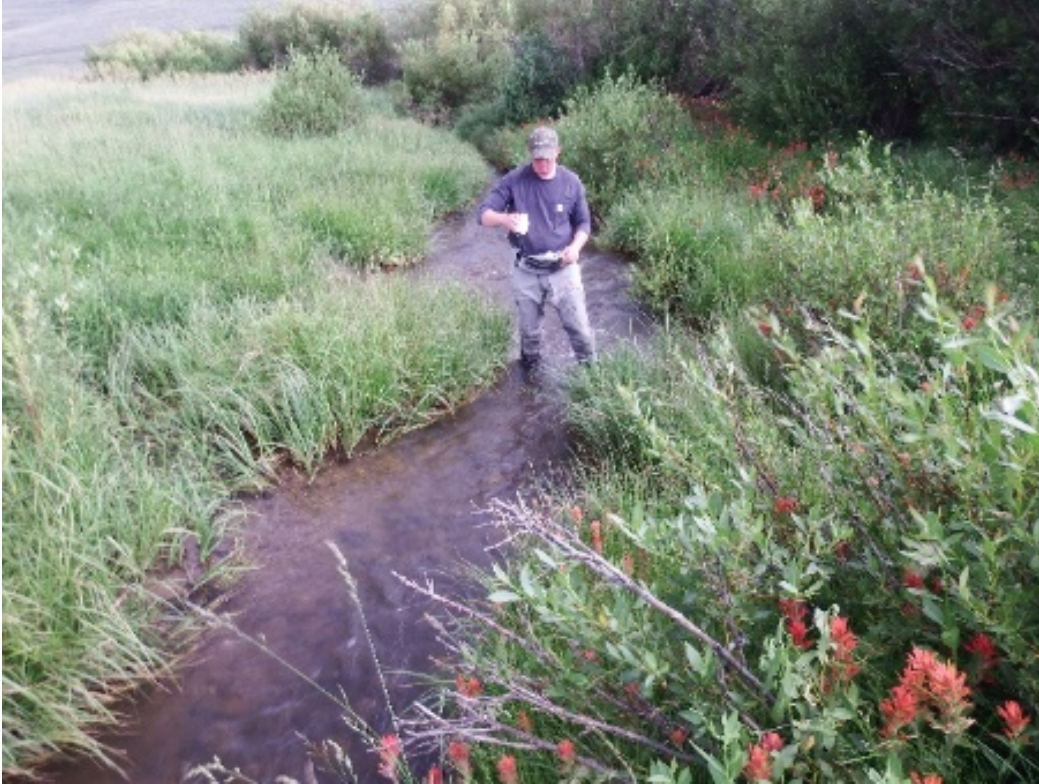
Figure 6-3. Gravel substrate and riparian vegetation at site ECLV07-01

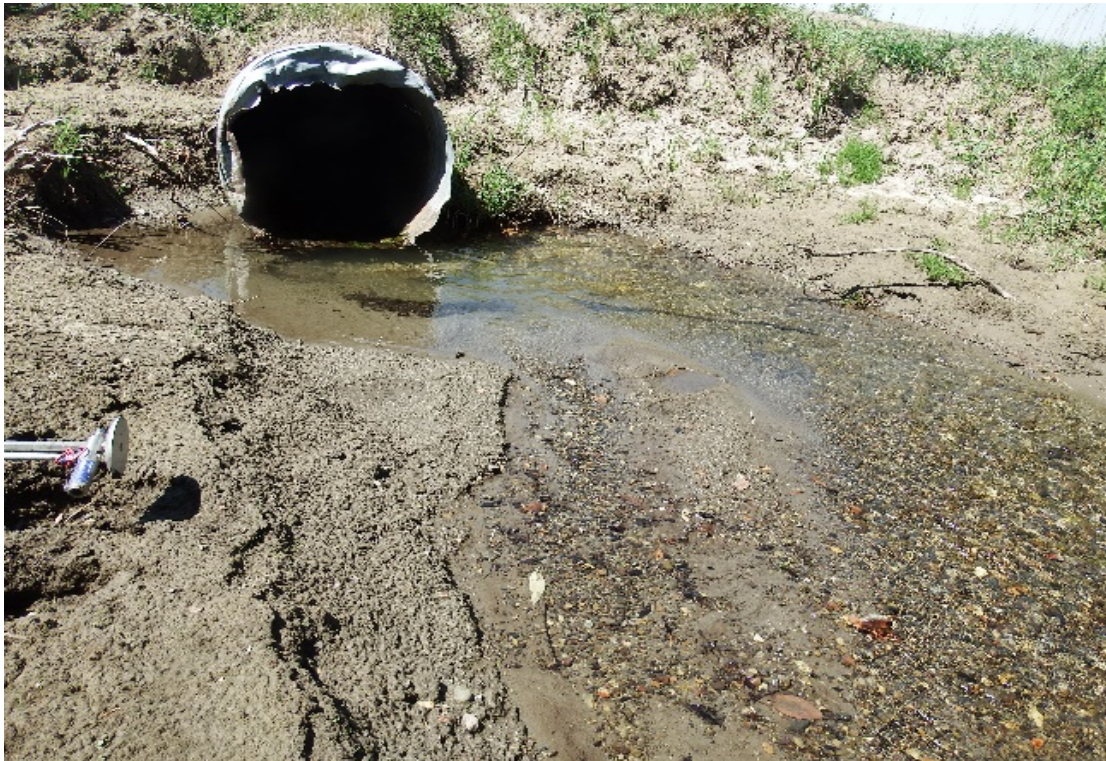
Figure 6-4. Culvert and siltation in Jones Creek about two miles downstream of the South Valley Road crossing

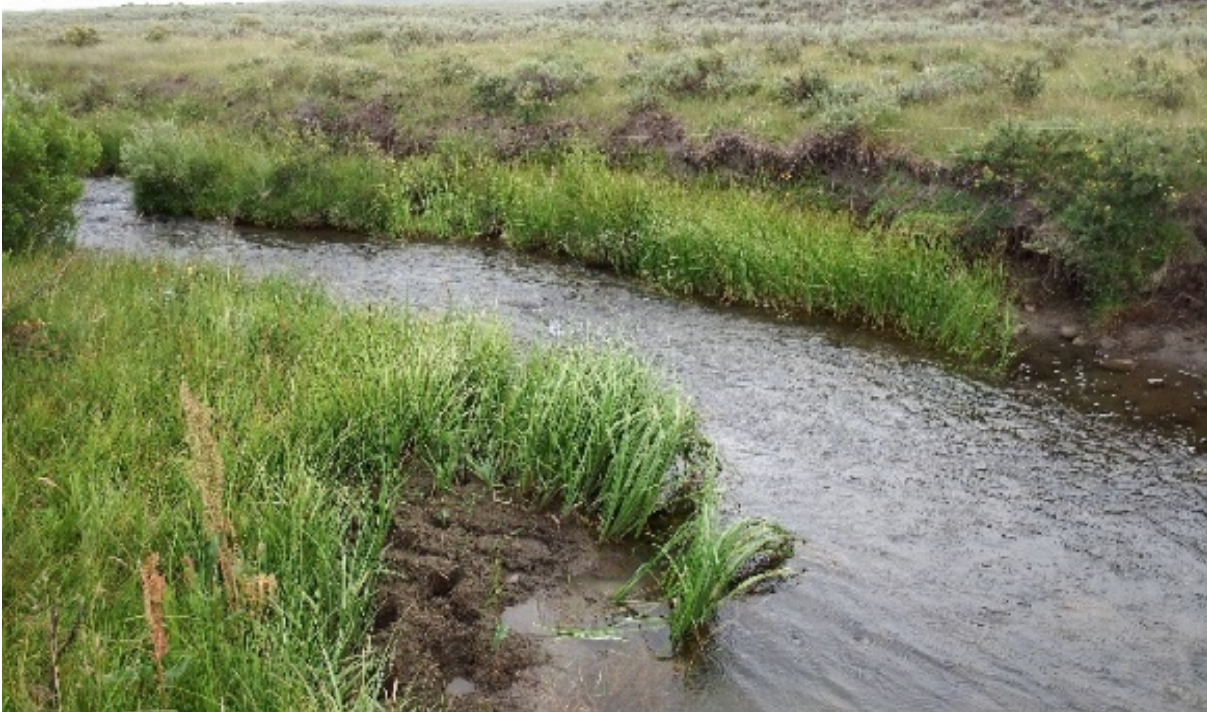
Figure 6-5. Condition of banks at LONG06-01a

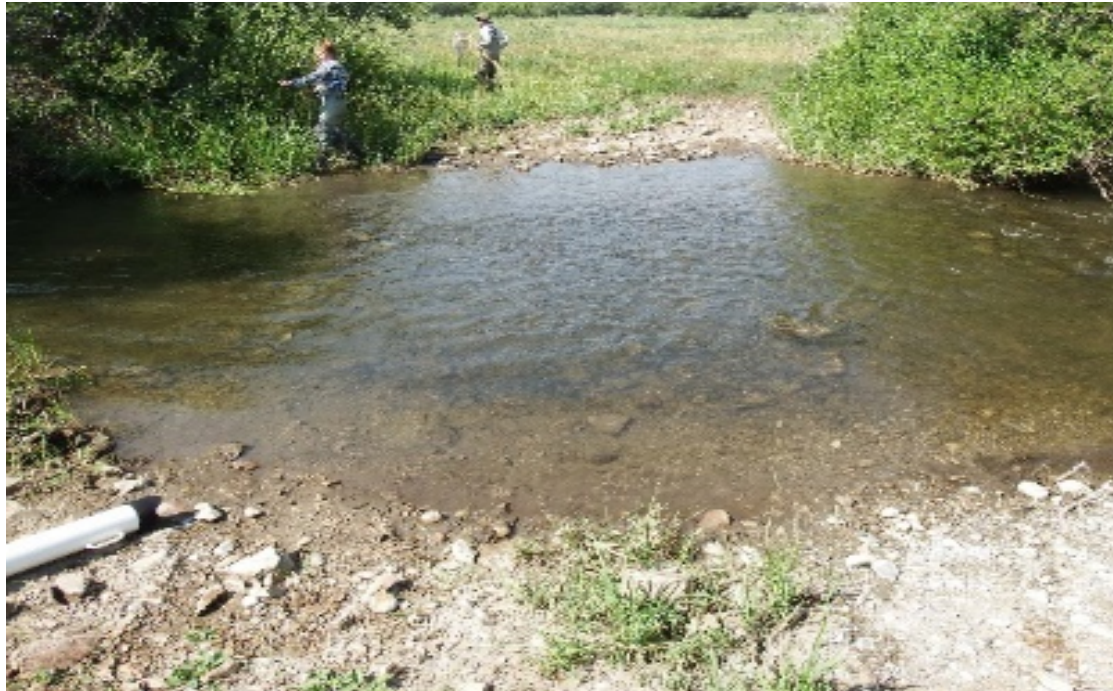
Figure 6-6. Unpaved crossing at site MDLG06-05a

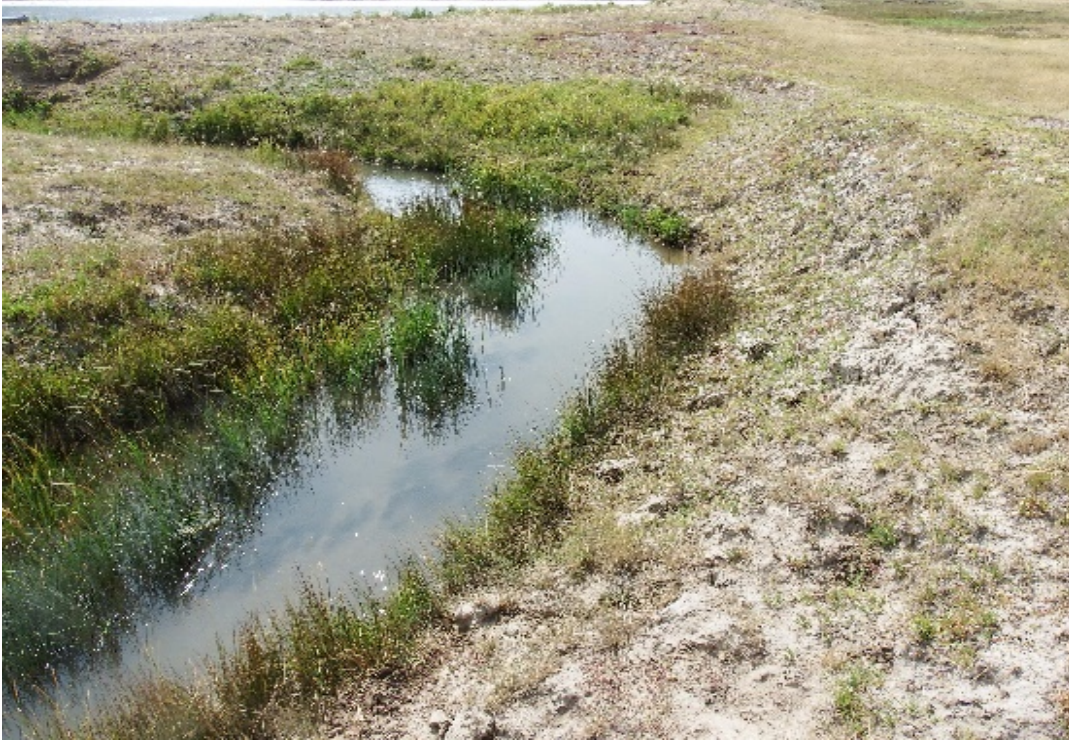
Figure 6-7. Trampling of banks on Peet Creek near the South Valley Road crossing

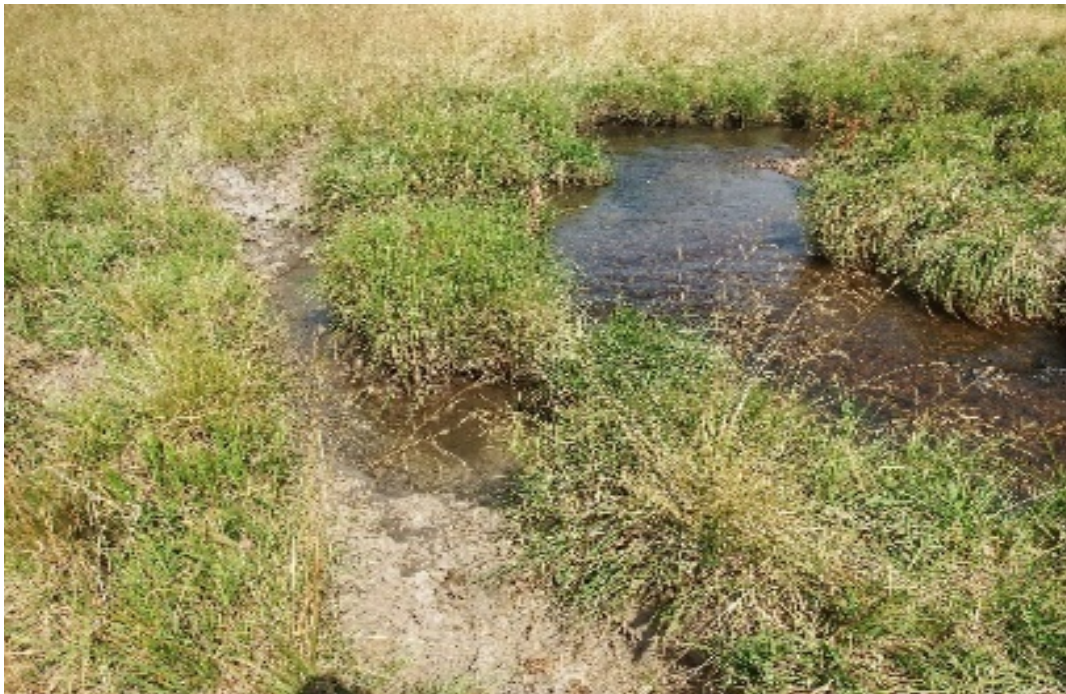
Figure 6-8. Heavily grazed area along site SELC06-01a

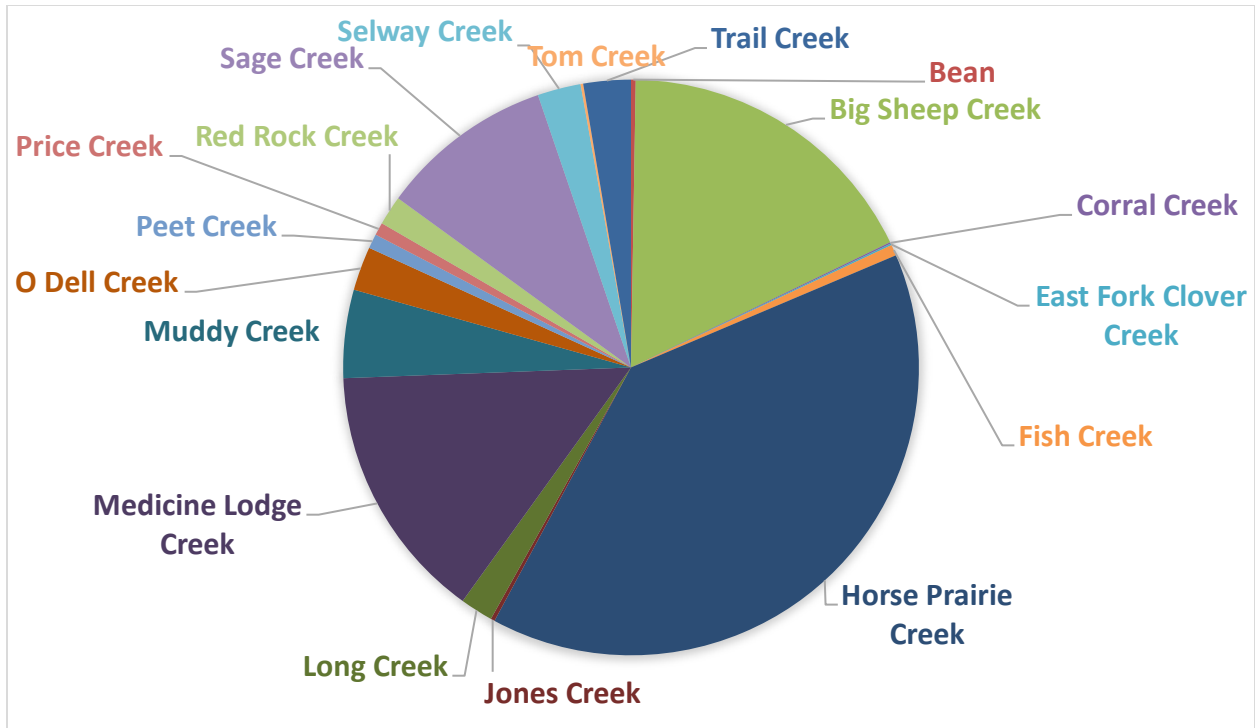
Figure 6-9. Estimated Relative Contribution of Sediment from Unpaved Roads by Subwatershed

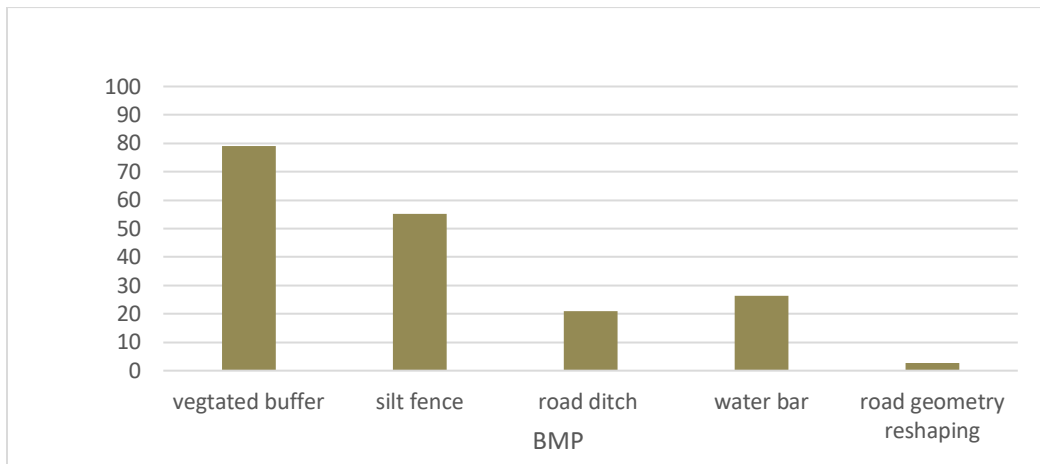
Figure 6-10. Percent of 38 parallel road segments or crossings sampled by the USFS with each recommended BMP

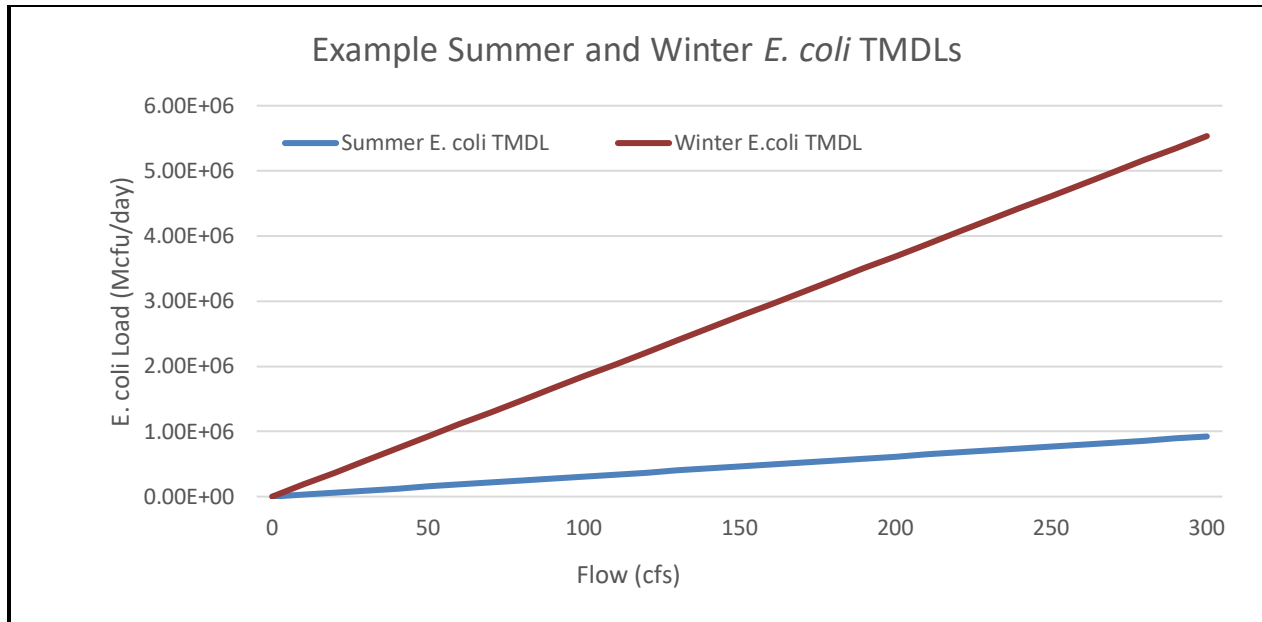
Figure 7-2. TMDLs for *E. coli* at stream flows ranging from 0 to 300 cfs
